Infrared Applications in the Fields of Forensic & Construction Defect Engineering

*Edward L. Fronapfel & Eric G. Amhaus
Professional Investigative Engineers*

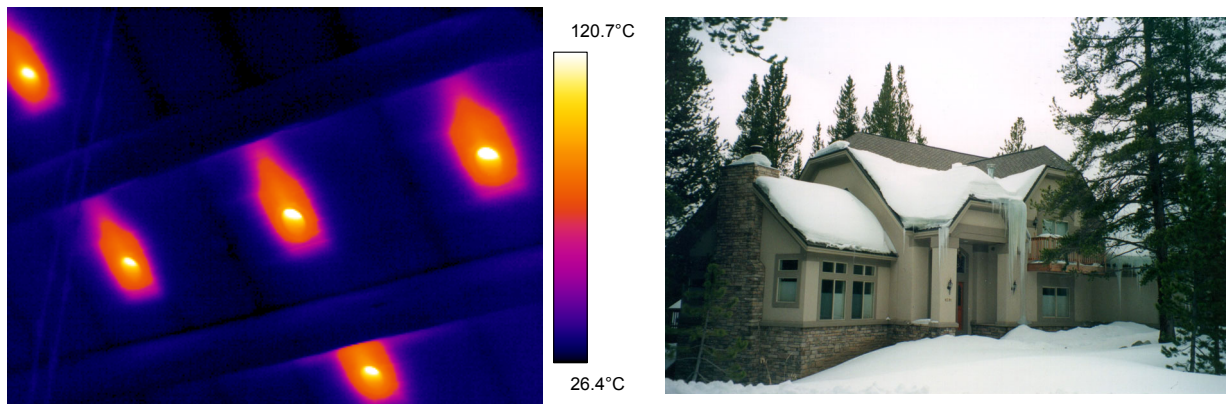
Figure 1. Heat transfer patterns from recessed can lighting in the cathedral ceiling of single family log home in Steamboat Springs, Colorado resulted in significant ice damming (left). Such conditions can result in ice damming on either super-insulated or inadequate cold roof systems as shown on this home in Blue River, Colorado (right).

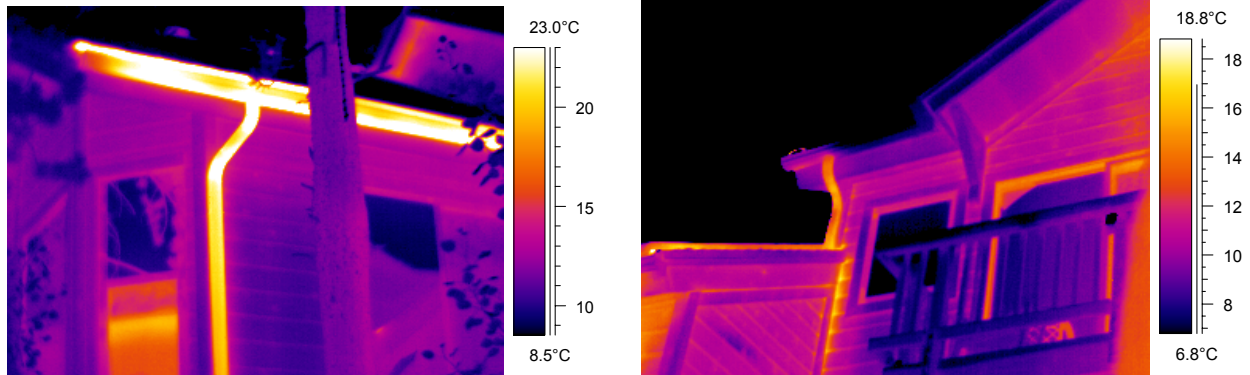
Figure 2. Ice melt/heat cable system investigation on multi-family property in Breckenridge, Colorado (left). Note active system in gutter and downspout in Image 1 and partially non-operating gutter system in Image 2. This inactive heat cable section was found to be the result of a damaged cable and connection (right).

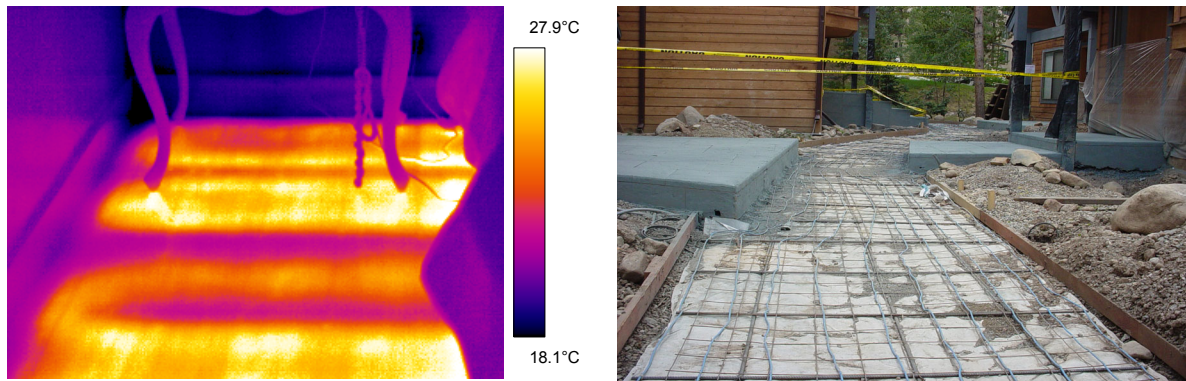
Figure 3. In-floor radiant heat system investigation at single family home in Wolcott, Colorado (left). Electrical heat system for snow melt in exterior walkway at townhouse complex in Breckenridge, Colorado (right). Note that IR can be utilized both prior to the pouring of the concrete as a quality assurance procedure or long after the concrete is poured to identify heating malfunctions.

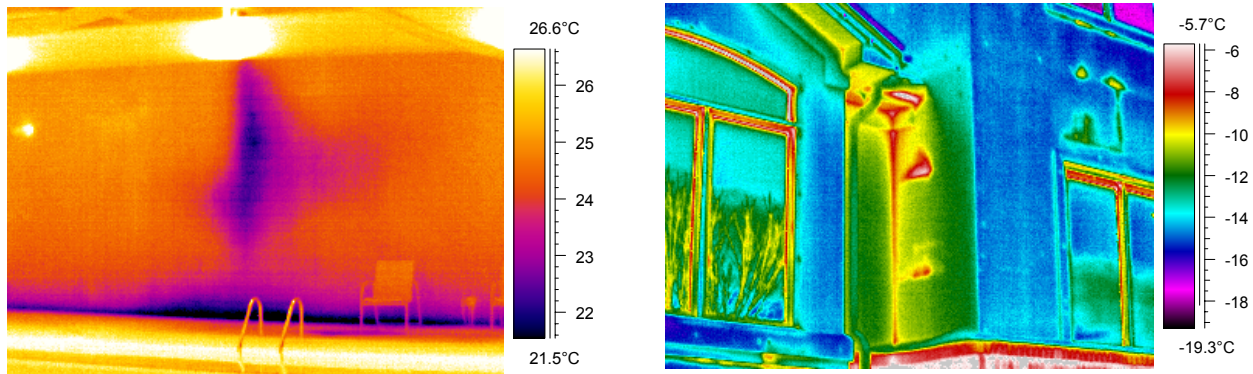
Figure 4. Interior moisture (left). Missing sheet metal "kicker" flashing at a roof-to-wall interface has resulted in moisture infiltration behind the EIFS façade of a single family home in Parker, Colorado (right).

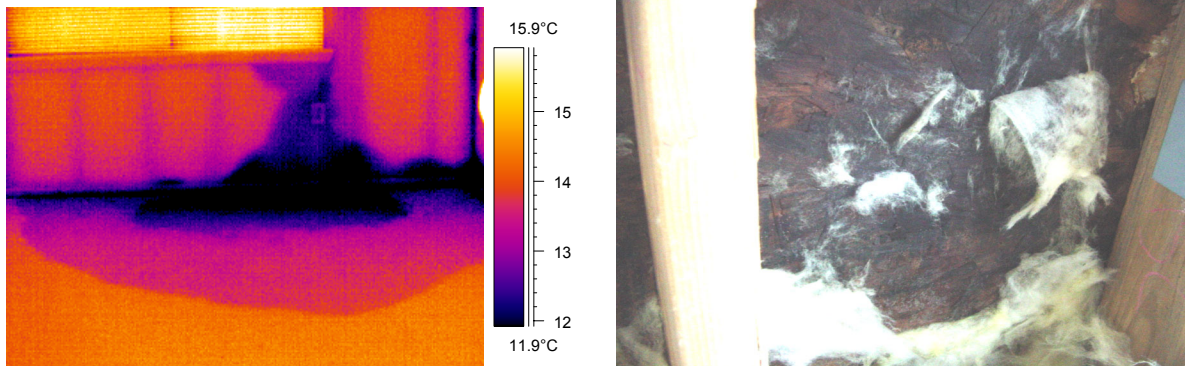
Figure 5. Improperly terminated / sealed stone veneer to window frame and missing flashings resulted in moisture infiltration into the wall cavity and interior living space in a multi-family apartment building in Greeley, Colorado (left). Water infiltration into a wall cavity can result in deterioration of the sheathing and the possibility for biological growth or mold as seen here on this single family residence in Windsor, Colorado (right).

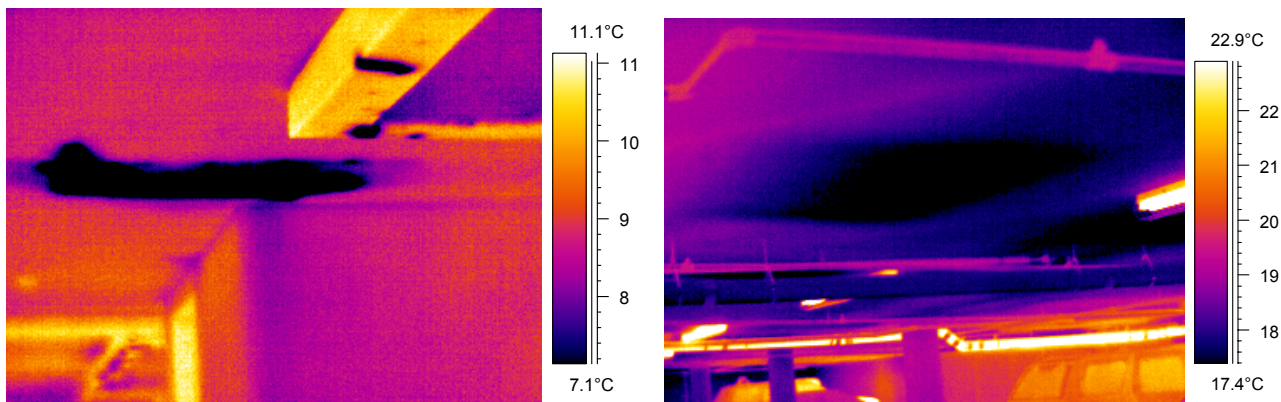
Figure 6. Improper flashing at balcony-to-wall connections and missing perimeter drainage system resulted in moisture intrusion into the wood framing support structure of the exterior walkway balcony of a loft complex in Denver, Colorado (left). A missing composite drainage plane or medium on a below-grade parking garage plaza deck structure in Cherry Creek, Colorado resulted in standing water between the structural concrete deck and the plaza wearing surface (right).

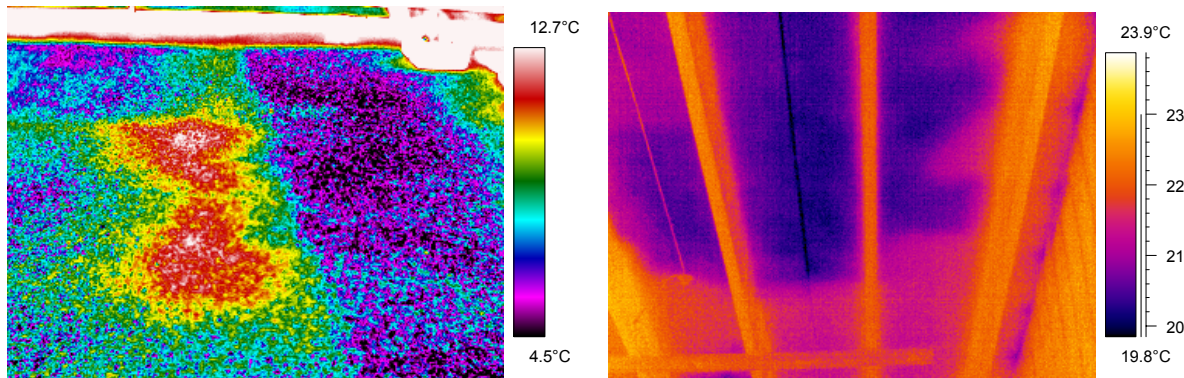
Figure 7. Moisture infiltrated BUR (Built-Up Roof) assembly on a low slope manufacturing facility in Cheyenne, Wyoming (left). Water-damaged roofing components and insulation identified from infrared scan from the underside of the built-up roof on a structural concrete tee deck (right).

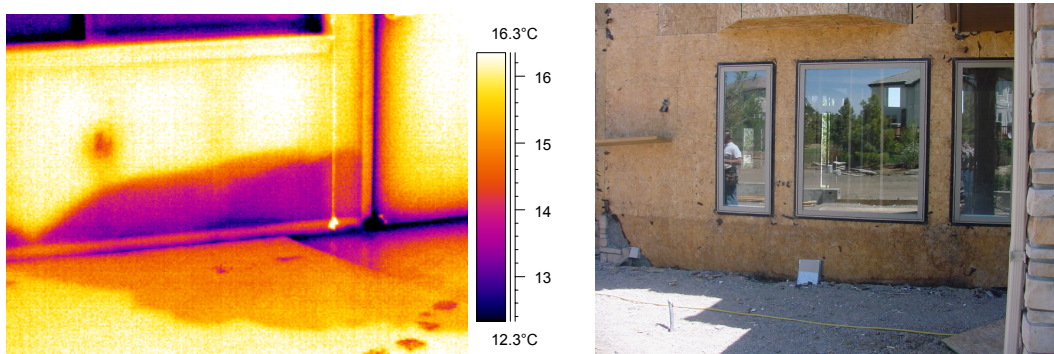
Figure 8. Moisture migration into drywall from capillary drive and interior finish components from inadequate clearance and slope of grade from vinyl siding façade on an apartment complex in Loveland, Colorado (left). Example of where OSB sheathing and façade materials had begun to deteriorate because they were not withheld above the at-grade soils (right).

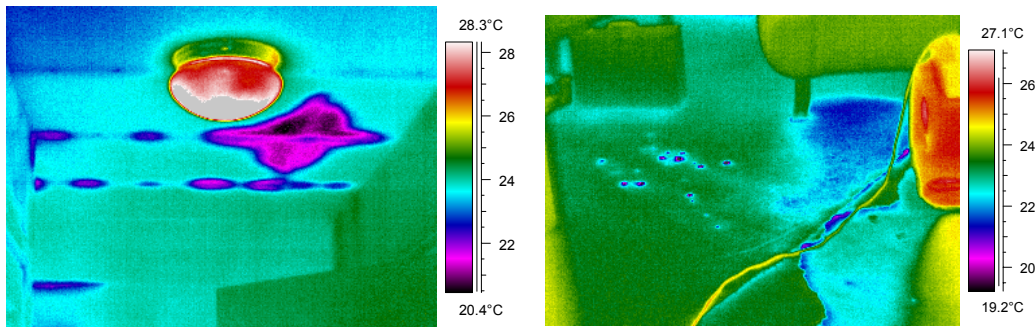
Figure 9. Moisture migration tracking along steel joist channels inside ceiling of a single family home where a plumbing line had ruptured in Morrison, Colorado (left). Water from plumbing leak was found to have migrated farther than originally anticipated by the contractor during remediation techniques of cutting back carpet and installing dehumidifiers – note wet carpet under chair that was not removed (right).

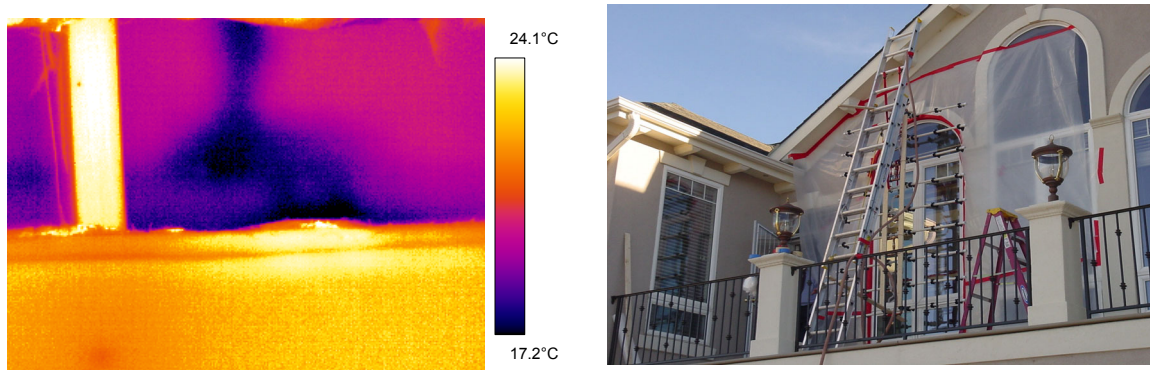
Figure 10. Moisture migration path detected between exterior gypsum sheathing and EPS (expanded polystyrene) insulation component of EIFS system at intrusive test cut under window sill on high rise loft complex in Denver, Colorado (left). Overview of an ASTM E-1105 water spray test (right) for investigating leaks in windows and different façade types.
