# Non-Invasive Roof Leak Detection Using Infrared Thermography

*Scott Wood,  
Four Star Cleaning and Restoration, Inc.*

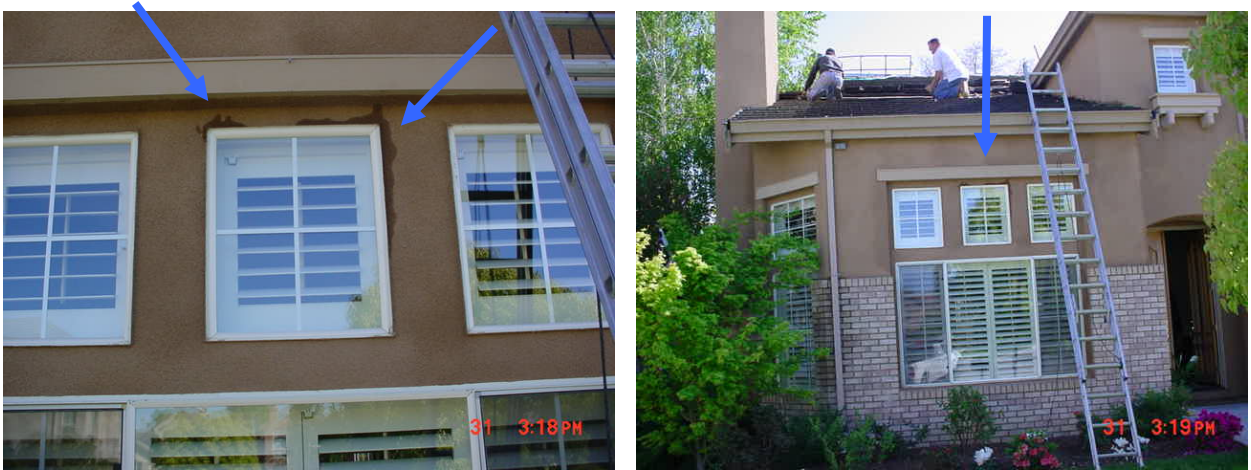
Figure 1. Exterior views of the front of the residence showing the location of water exiting the stucco surrounding the center window (blue arrows), indicating water had entered the wall system above the window.

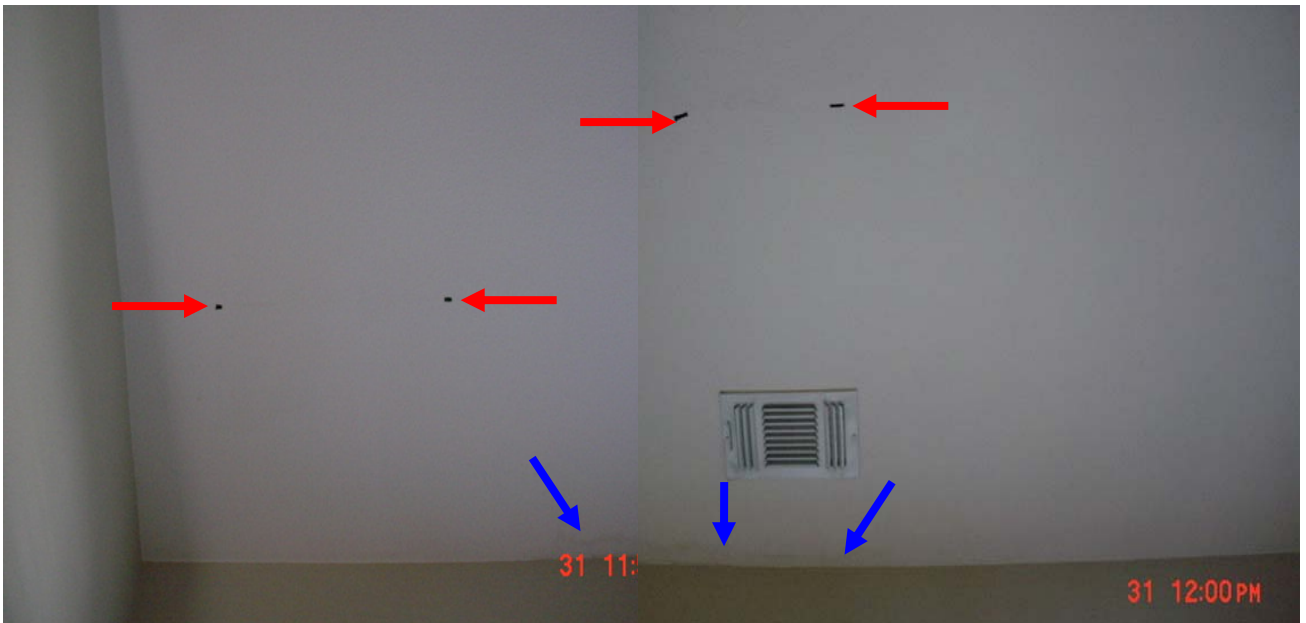
Figure 2. Visual image of the living room ceiling showing the water staining caused by the roof leak. The blue arrows show the staining along the ceiling-wall joint directly under the supply register. Black marks (pieces of tape indicated by red arrows) are reference points for the wallboard separation, only visible upon close examination between the tape marks.

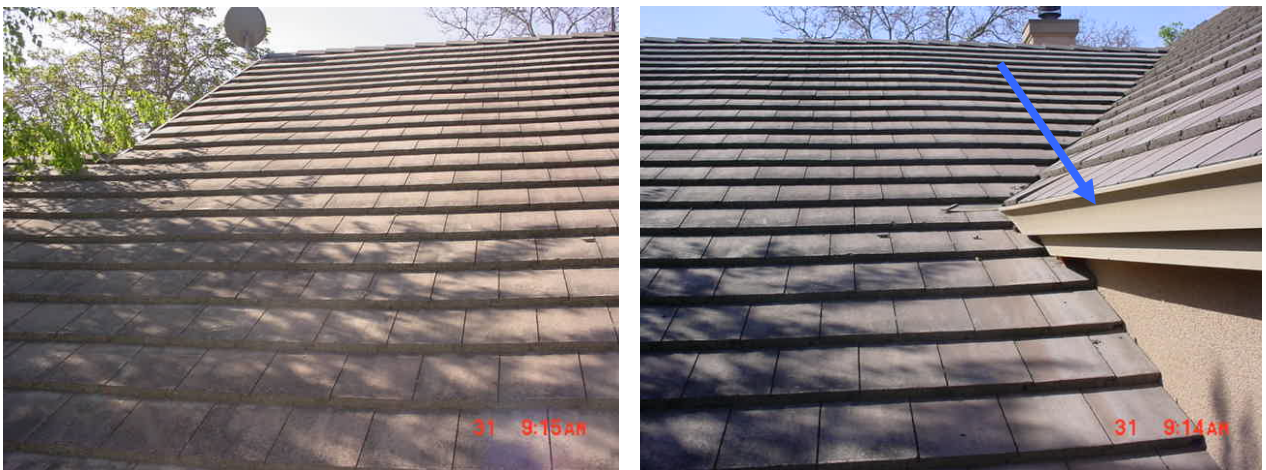
*Figure 3. Visual images of the roof showing the cement roofing tiles intact (without cracking, separation or missing tiles). The gutter system at the right (see blue arrow) did have unusual construction, as shown in Figure 4.*

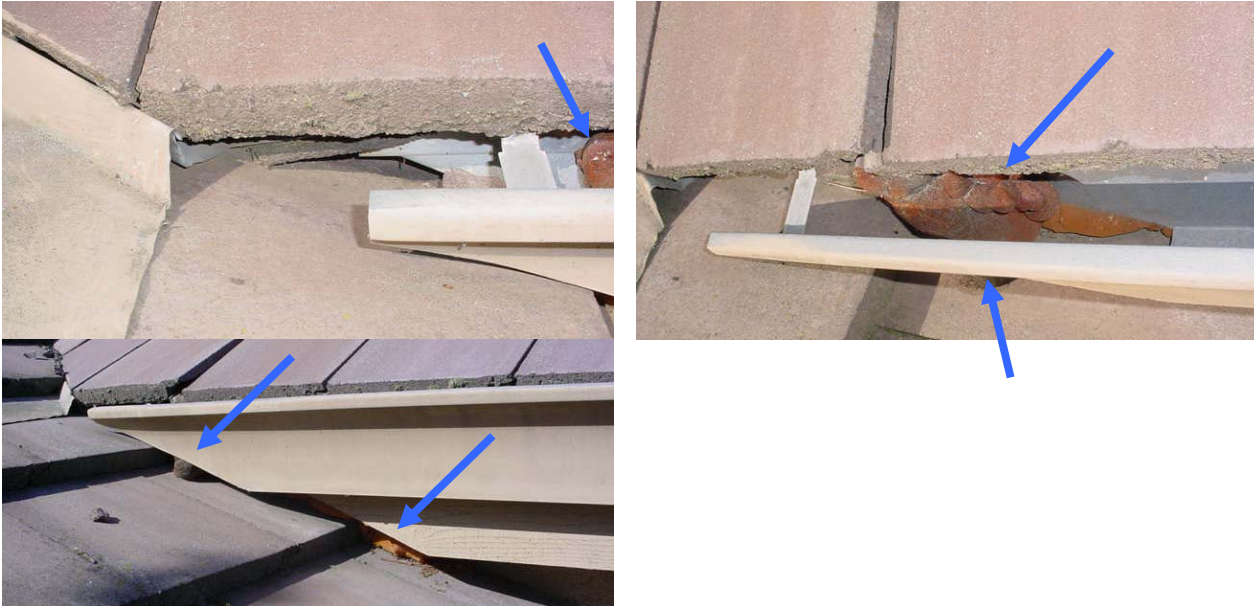
*Figure 4. Visual images showing a close-up of the gutter system (Fig. 3) where foam was applied. The foamed area (blue arrows) may be covering a possible water intrusion point.*

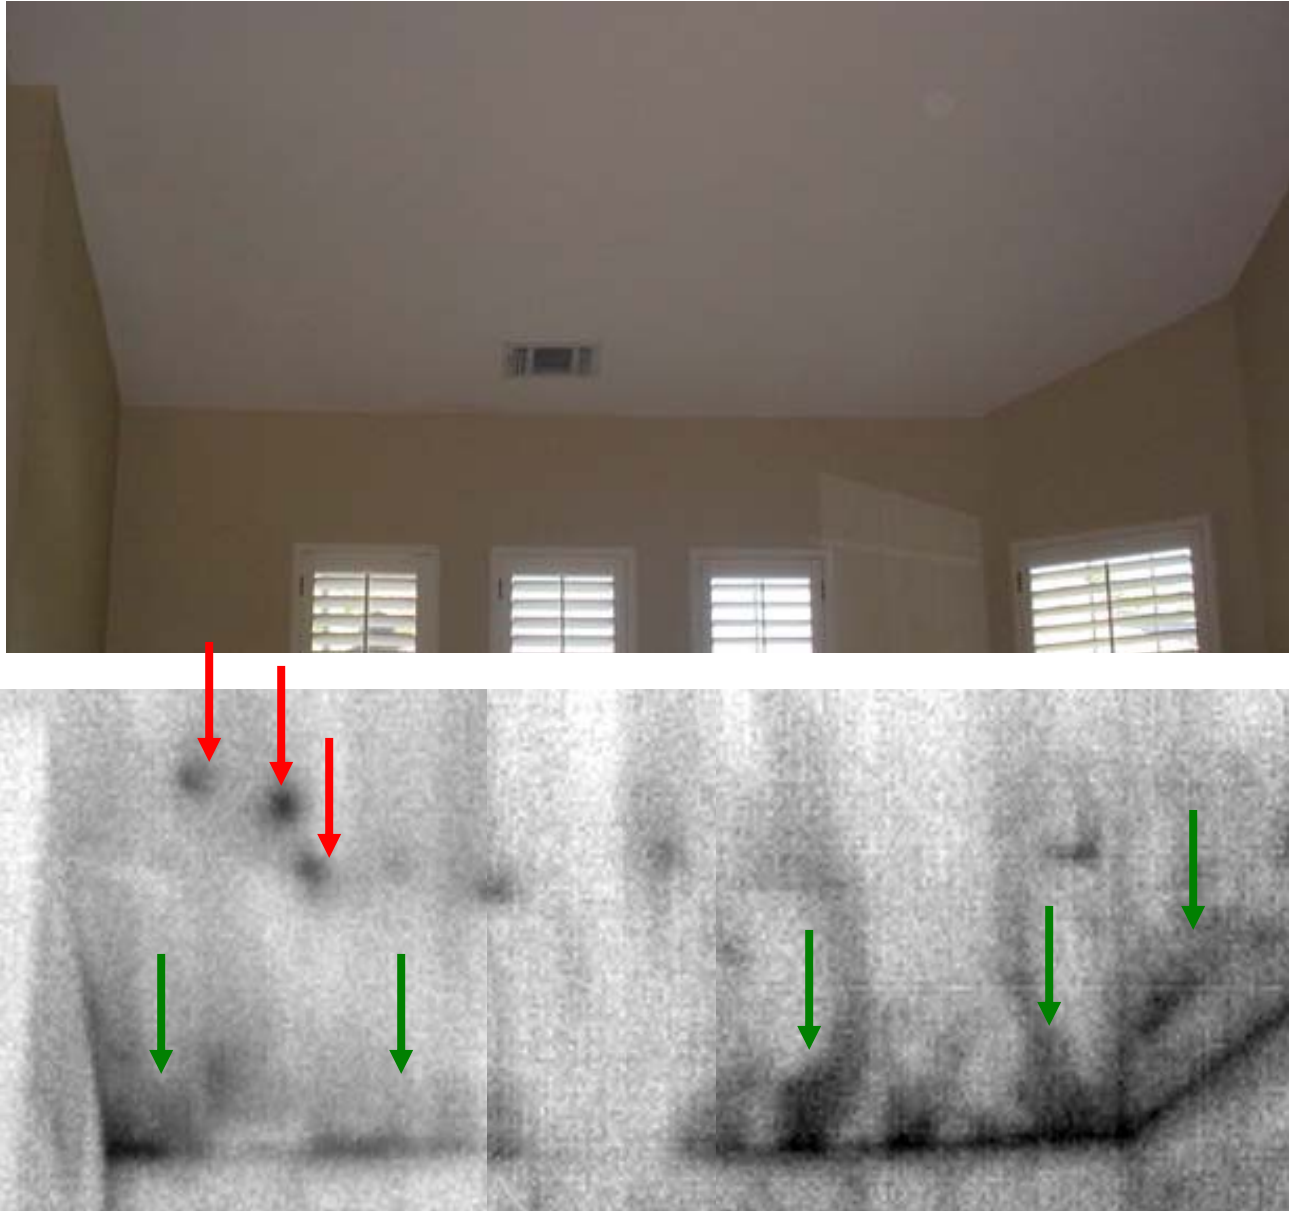
*Figure 6. Visual image of the ceiling as well as infrared thermograms showing a thermo baseline of the ceiling where the water leak should be visible. The cooler areas indicated by the green arrows are due to insulation gaps. It is unclear why the areas indicated by the red arrows were cooler than the surrounding wallboard. Moisture readings show no moisture differences in all the areas visible in this image.*

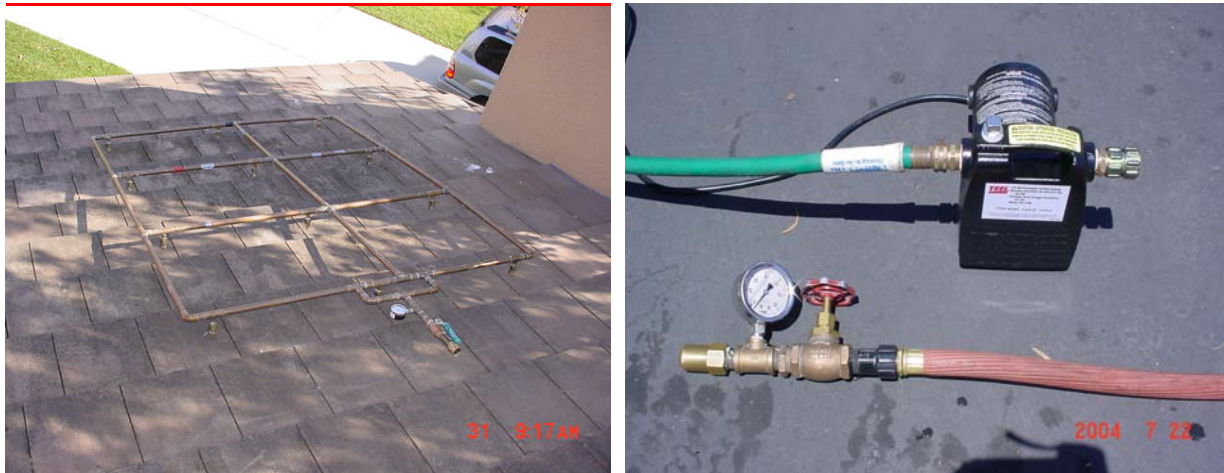
*Figure 7. Images of the spray rack system (left) and the hand-held spray applicator (right) used to apply water to the roof. The hand-held sprayer was used to apply water to the suspect area located at the gutter.*

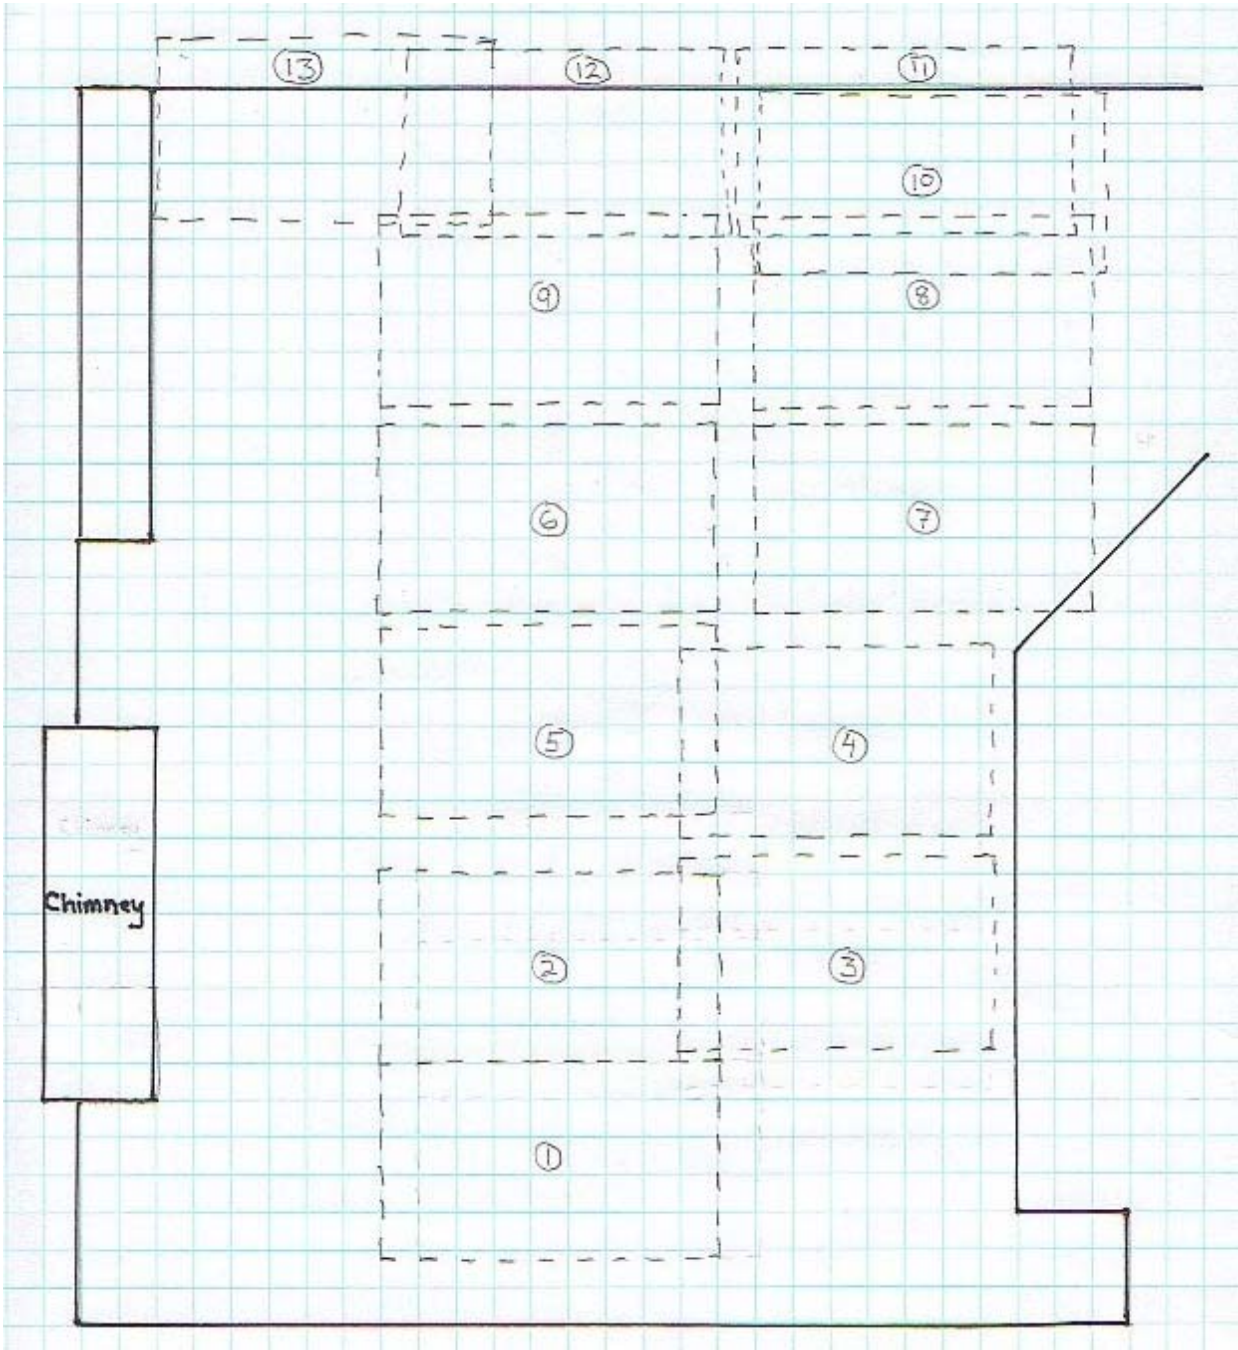
Figure 9. Diagram of the roof showing the positions, 1-13, of the location of the spray rack

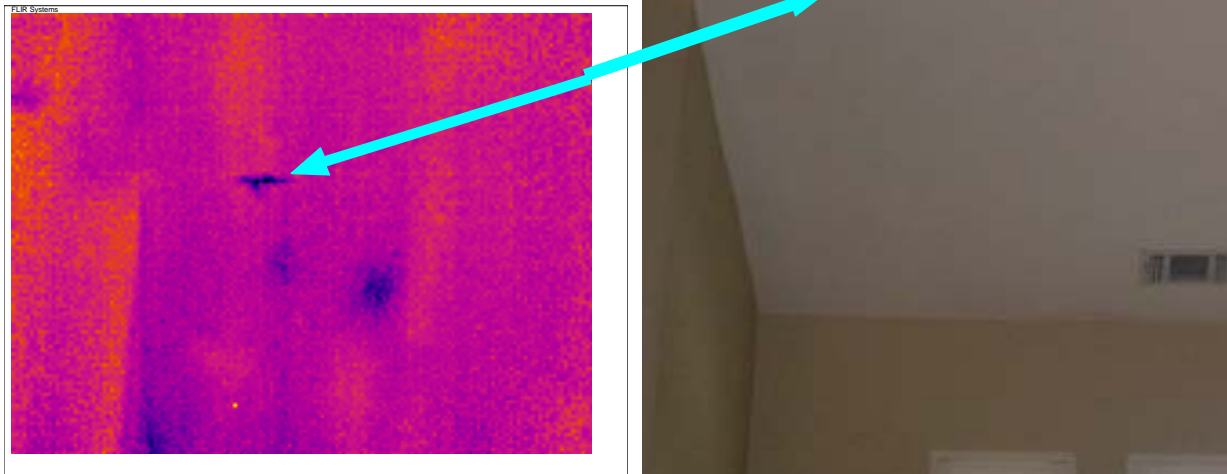
Figure 10. Thermogram/photo pair showing the beginnings of the water intrusion. Cool spot indicated by the arrow was tested for moisture with a moisture meter to confirm the presence of moisture.

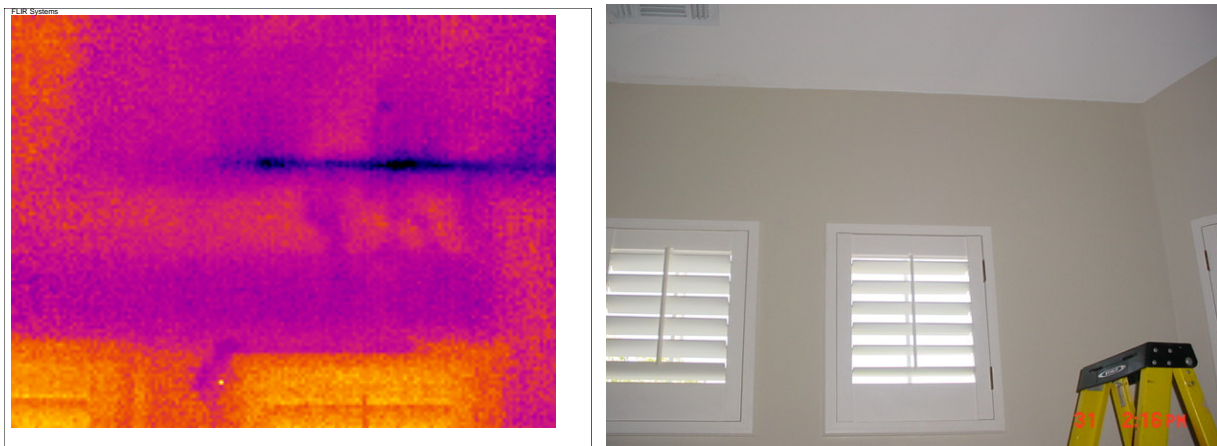
Figure 11. Thermogram/photo pair showing the water intrusion moving to the front living room wall

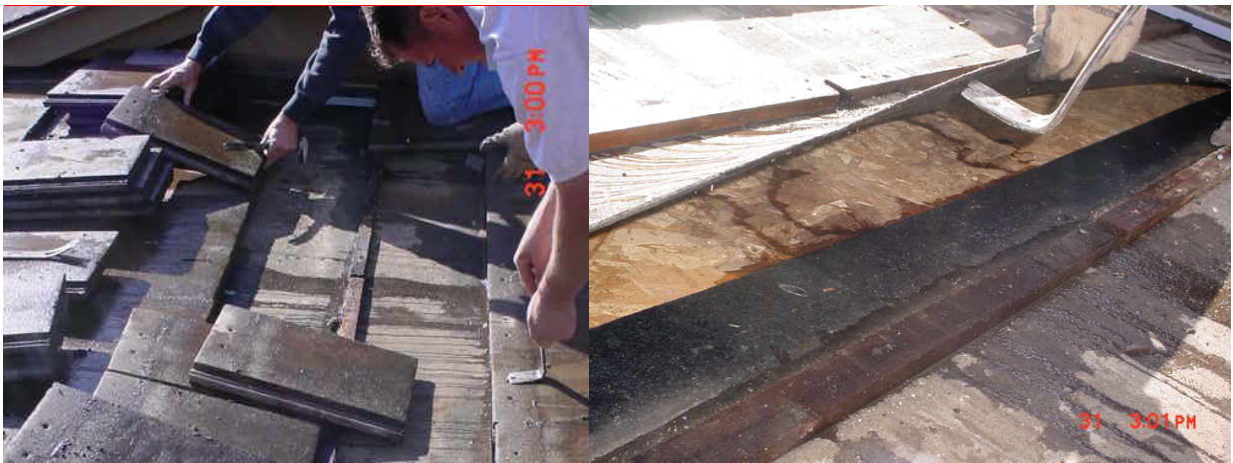
Figure 12. Images showing water under the tiles (left) and under the roof's underlayment (right). Note the location of the area in reference to the gutter at the upper left side of the left image.

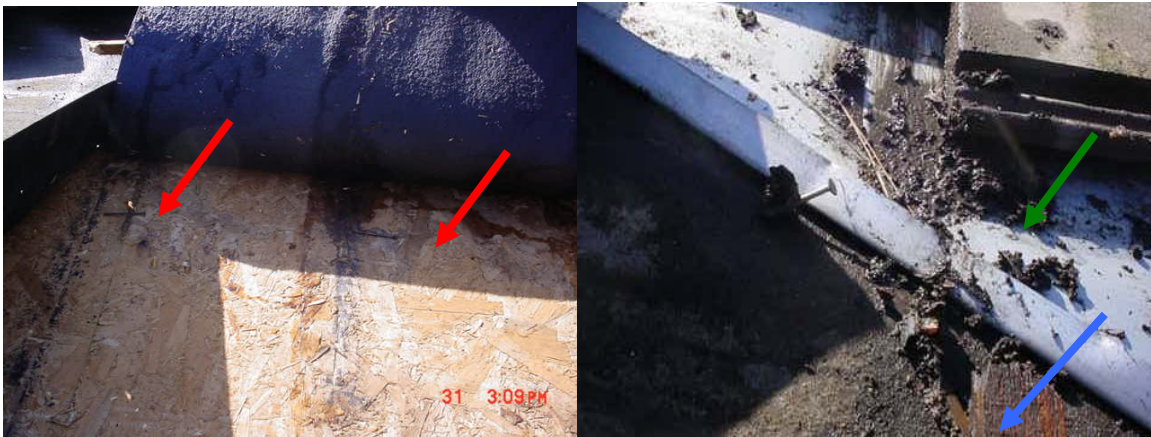
Figure 13. Image (left) showing the underlayment and roof sheathing, as well as two nails (red arrows) found lying on the roof sheathing. The heads of the nails penetrated the underlayment, causing water to flow onto the roof sheathing and then into the residence. The image on the right shows remains of the debris dam and the edge of the flashing (green arrow) where the water spilled over (blue arrow).

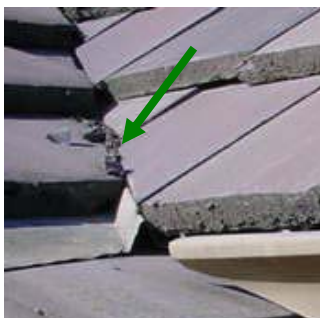
Figure 14. Image showing the debris dam at the roof valley before the tile was removed.
