## Using Infrared for Residential Energy Surveys

*Dave McCullen  
Sumter Electric Cooperative Inc.*

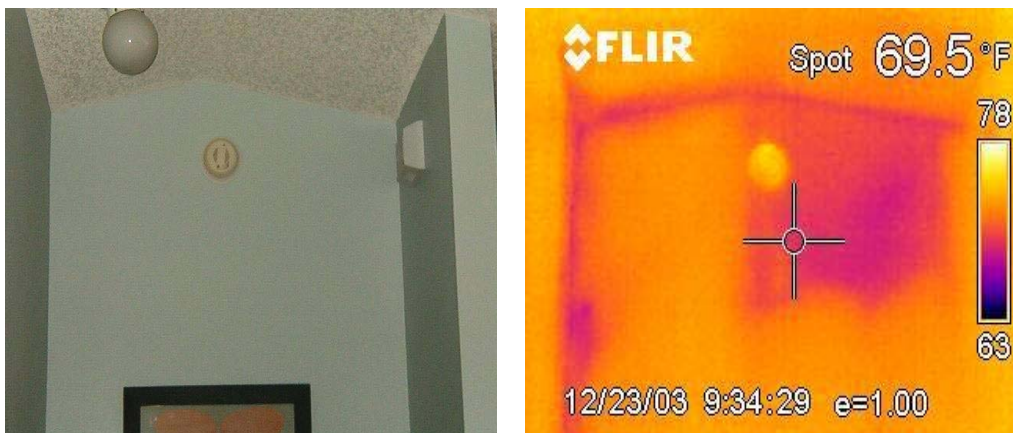
*Figure 2. Areas of heat loss through a standing wall that is not insulated*

Standing walls in a home that are not adequately insulated can be significant areas of heat loss or gain, especially when large temperature differentials occur on each side. Figure 2 shows large gaps in the standing wall insulation between different ceiling heights. Attic inspection revealed that the insulation had been pulled away from the wallboard, allowing cold attic air to get behind the insulation and cause heat loss into the attic. The problem was evident in several areas of the same home.

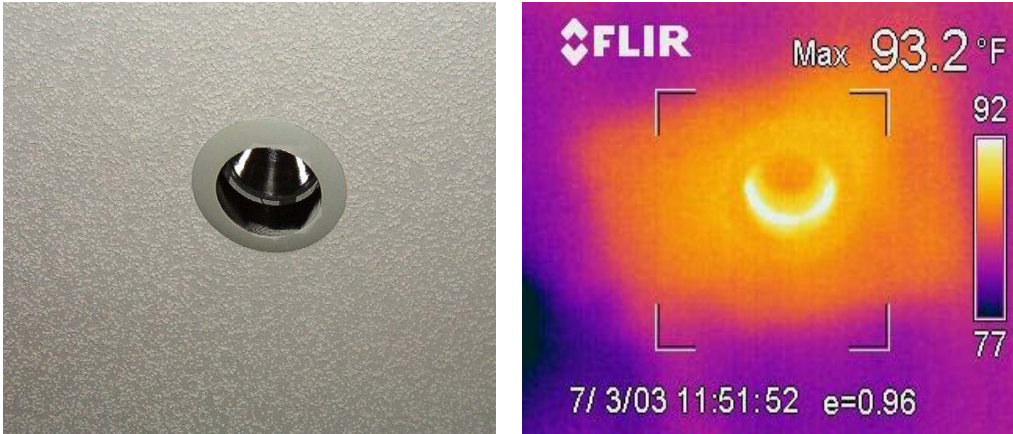
*Figure 3. Ceiling penetration and insulation problem*

Ceiling penetrations can be significant heat gain or loss areas if numerous and not adequately sealed. In Figure 3, the fixture was not on, and the thermograph revealed that the insulation around the fixture was not adequate. Attic inspection revealed that the insulation had been pulled away from the fixture on all sides and that the fixture was not sealed.

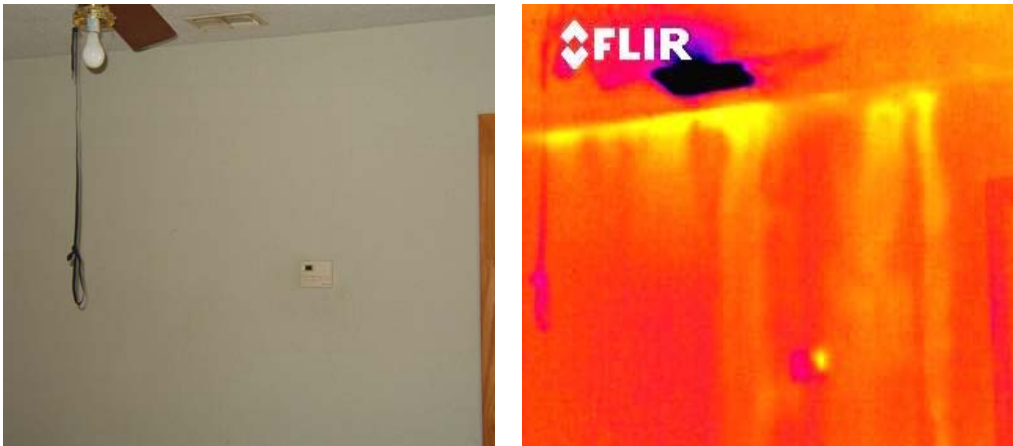
*Figure 4. Thermal ducting inside a hollow wall behind the thermostat*

Without the use of infrared, one of the hardest problems to find in a home is the existence of thermal ducting inside the wall structure affecting the regulation of the system. This phenomenon affects the HVAC running time by infiltration of humidity and heated air into the conditioned space. It can also affect the thermostat by heating or cooling the wall behind it, thereby greatly extending the time the thermostat calls for conditioning. Figure 4 illustrates this phenomenon very clearly. The return was cut through a hollow wall, and the passage was not sealed from the wall cavity. When the unit was running, the resulting low pressure inside the return passage lowered the pressure inside the wall, and hot attic air moved in to replace it. The thermostat visible on the wall was set at 80°F, but the wall temperature just under it was 87°F. This caused the unit to keep running almost constantly. Without the thermograph, this problem would be difficult, if not impossible, to find. Figure 5 shows the same ducting situation in another home during the winter heating season. Notice the cooling of the wall behind the thermostat.

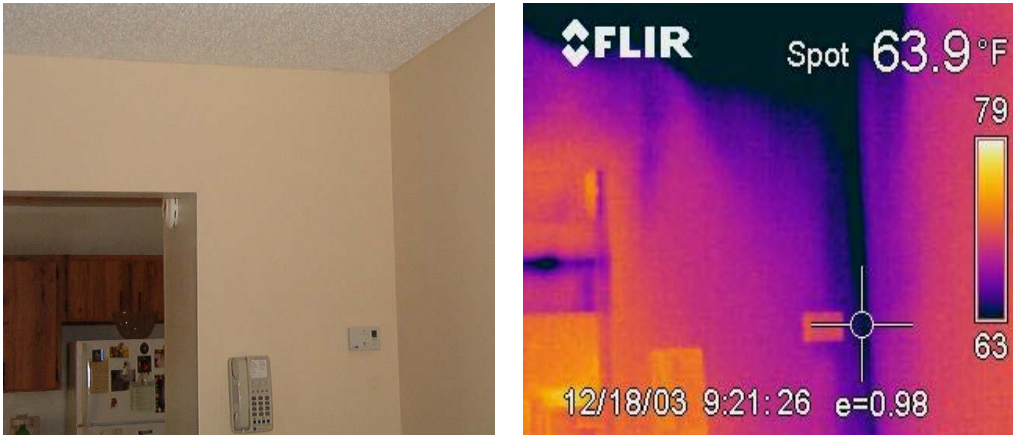
*Figure 5. Cold air being drafted in a hollow wall behind the thermostat*

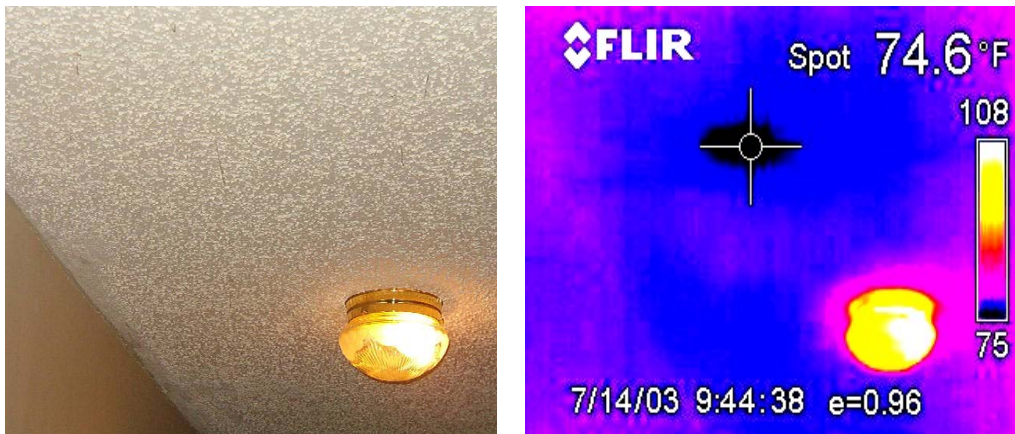
Figure 7. Cold spot on hall ceiling caused by supply junction leak in attic over ceiling board

Figure 7 shows a cold spot on the hallway ceiling that indicated a possible leak in the supply system in the attic of this home. Attic inspection showed exactly that, as seen in Figure 8. In fact, the entire supply ductwork system in this home was leaking significantly at every junction, as well as the connection with the ceiling supply inlets, losing conditioned air into the attic. The thermograph, showing a cold spot where none should be, led to a significant find that otherwise could easily have been missed.

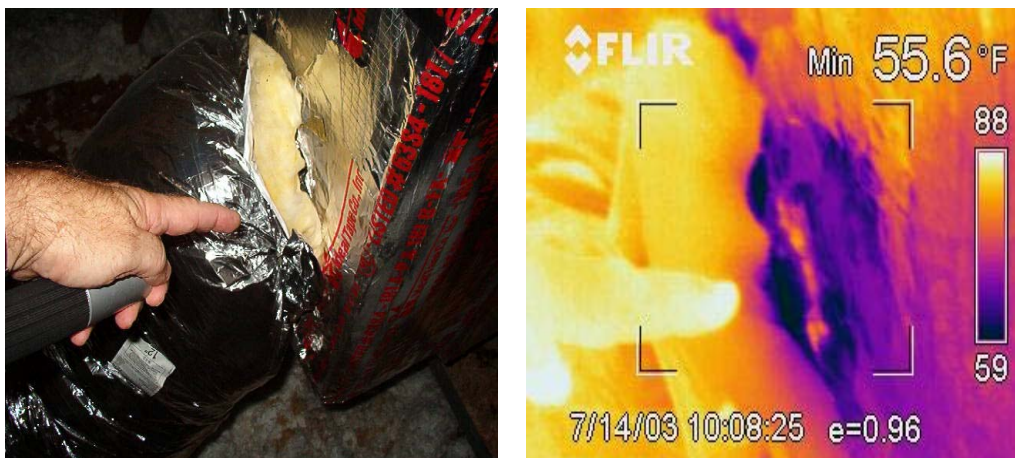
Figure 8. Supply junction of flex duct and disbursement box that was not sealed or taped

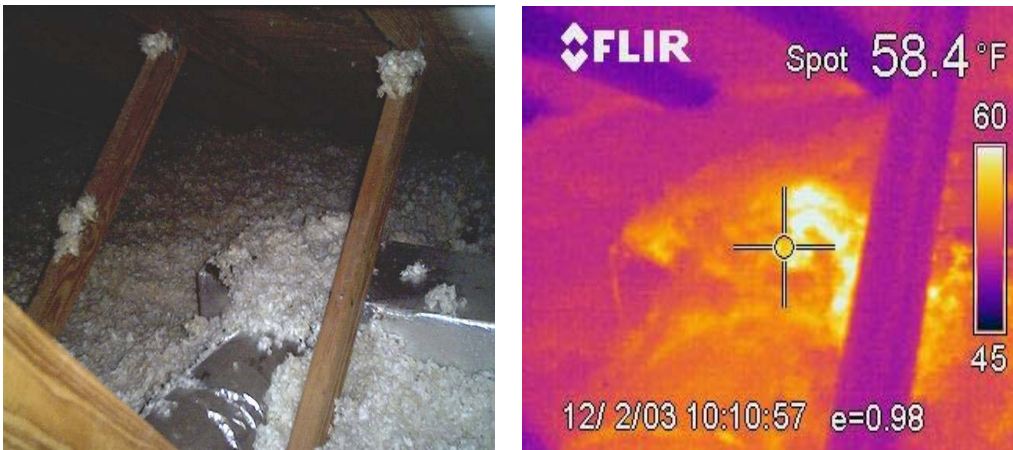
*Figure 9. Supply leak showing heat loss under blown-in insulation*

The most difficult supply leaks to find are those that are buried under the blown-in insulation. These can go undetected very easily, but in Figure 9 we see that the infrared will pick up the conditioned air infiltrating the insulation and indicate the leak. This leak was found in January during the heating season and was substantial, as seen by the amount of heated air shown infiltrating the insulation.

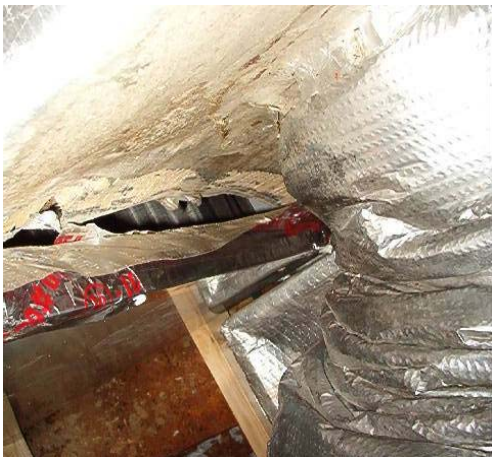
*Figure 10. Large leak in return plenum at air handler*

Return system leaks can greatly increase the amount of time that the HVAC system runs. If the return ducts are in the attic space, very hot, moist air can be drawn into the system, causing extended running times. In this situation the supply air will be significantly warmer than required, causing the unit to run longer to reach the thermostatic cut off. Also, because of the higher moisture, the unit must also run even longer to reach the dew point for conditioning the air. Figure 10 shows a leak in the return plenum at the air handler in the attic of a home in summer pulling in hot, moist air. The infrared shows the temperature of the coil that is visible inside the air handler at 44.2°F. The air in the attic was over 80°F. This leak was found by scanning the plenum with the infrared and noting the cold spot. Visual inspection with a flashlight found the problem. This home had all the symptoms: high humidity, unit running constantly, and very high utility bills.
